**Todd Prager & Associates**  
LLC

## **Level 2 Tree Risk Assessment**

### **Davis-Meeker Oak**

**Date:** October 14, 2026

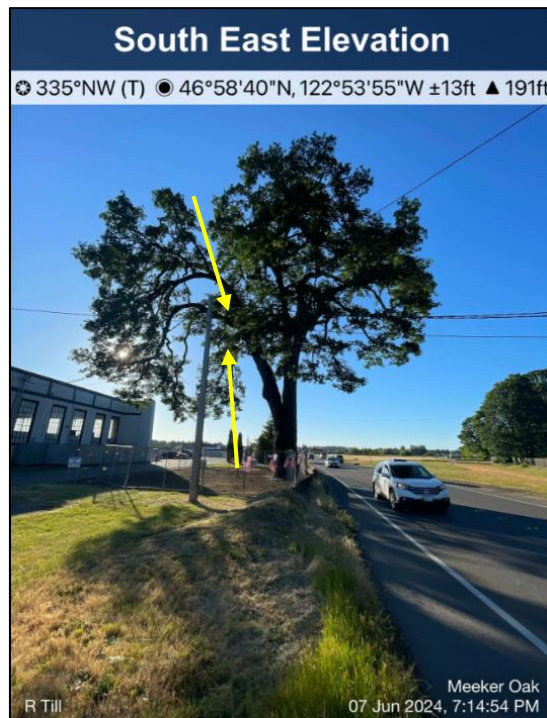
**Figure 1 (left)** The Davis-Meeker Oak in June 2024 prior to the branch failures. Note the two branches on the west side of the tree. Photograph taken by Rick Till.

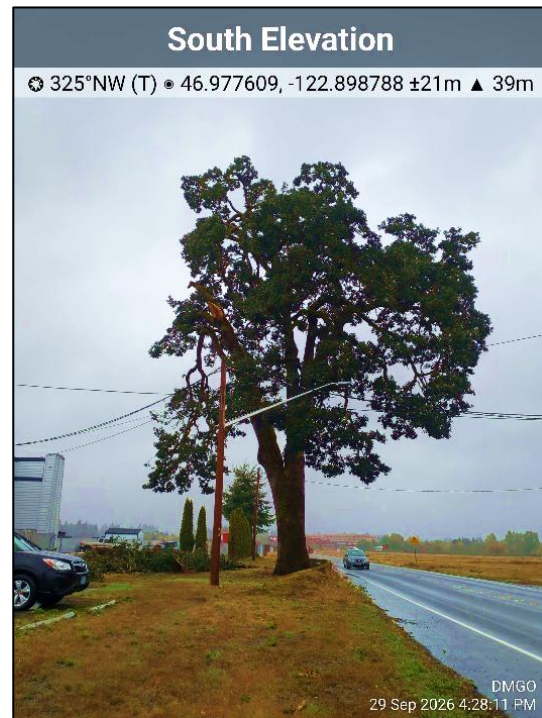
**Figure 2 (right)** The Davis-Meeker Oak on September 29, 2026, four days after the branch failures. Photograph taken by Christine Johnson and brightened for clarity.

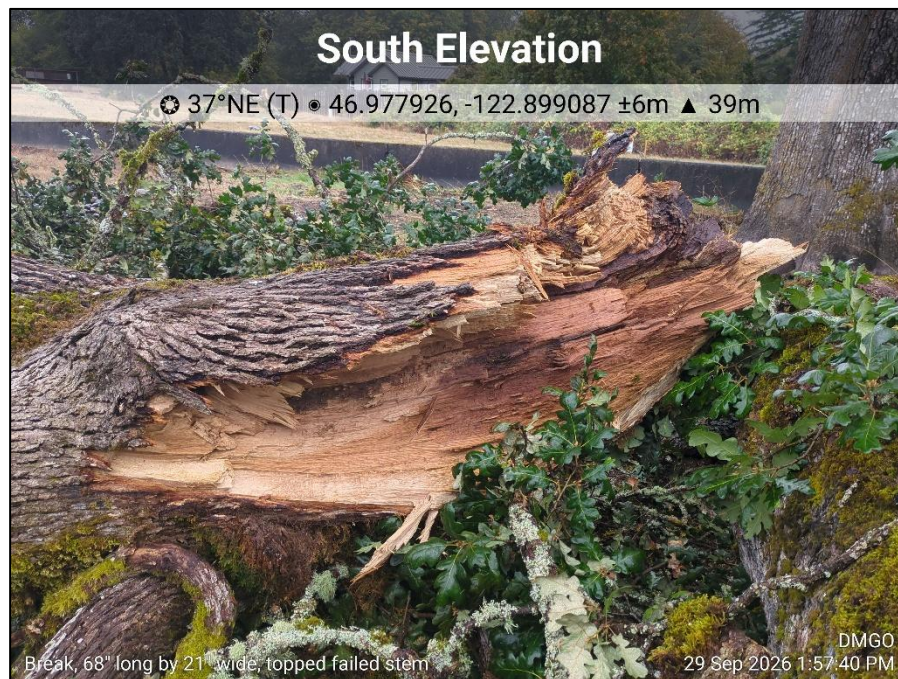
- **24-inch diameter branch at 50 feet AGL.** The upper branch failed at the point of attachment with the southwest stem. In review of photographs taken in 2024, this branch had a bowed branch architecture (Figure 1) with heavy end-weight. The area of fissured wood on the branch was 68 inches (5.5 feet) long by 21 inches (1.75 feet) wide (Figure 3). I inspected the area of attachment and did not observe any signs of a decay pathogen. I observed a column of decay 6- to 7-feet-long mid-way up the branch, but it did not appear to extend into the point of attachment with the southwest stem. The column of decay was not associated with a visible opening, though I was unable to move the large diameter branch for a full assessment.

- *Finding: It is my professional opinion that the 24-inch diameter branch failed due to high wind forces overcoming the wood strength at the point of attachment with the southwest stem. The branch was still fully leafed out, increasing its surface area and making it more susceptible to wind loading. The end weight of the branch also contributed to the failure.*

**Figure 3** The 24-inch diameter branch. The fissured wood measured 68 inches by 21 inches. Photograph by Christine Johnson.

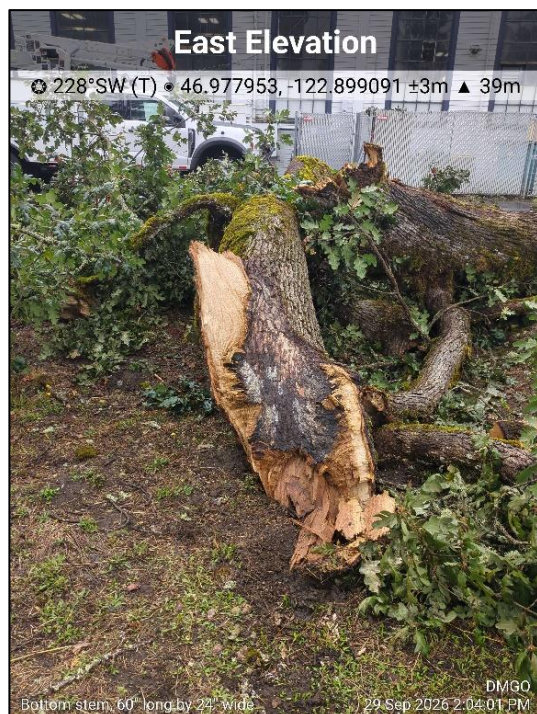
- **20-inch diameter branch at 35 feet AGL.** It is presumed that the upper branch failed and struck the lower branch causing it to break, however, to my knowledge there were no witnesses to the event. The area of fissured wood on the branch was 60 inches (5 feet) long by 20 inches (1.75 feet) wide (Figure 4). I inspected the area of attachment and observed white bubbling sap, discolored bark and sapwood, and moist soft wood tissue. This could indicate inclusion at the point of attachment or a fungal or bacterial pathogen. A wood sample exhibiting these symptoms was collected and sent to Oregon State University Plant Clinic<sup>8</sup> for diagnostic testing on October 5, 2026. Results are expected in mid-October 2026.

- *Finding: It is my professional option that the 20-inch diameter branch failed when it was struck by the 24-inch diameter branch. The branch attachment may have been weakened by inclusion and/or a pathogen, but those were likely not the cause of the failure.*

**Figure 4** The 20-inch diameter branch. The fissured wood measured 60 inches by 20 inches. Photograph taken by Christine Johnson.

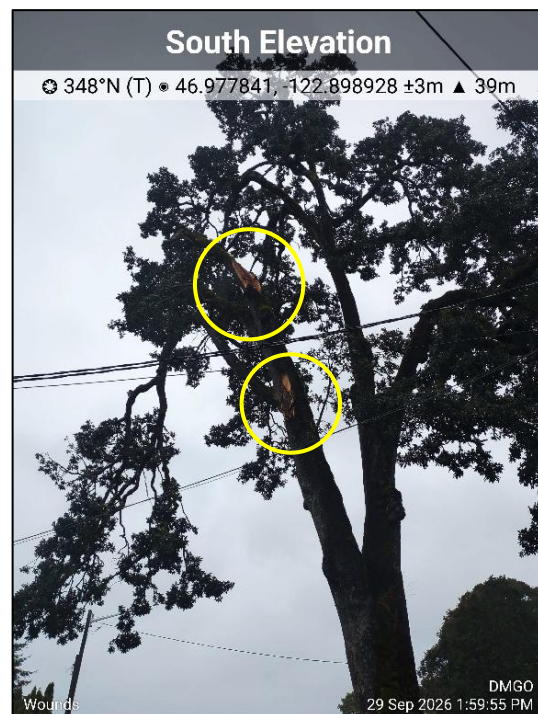
The two branch failures have left significant wounds on what remains of the west/southwest stem (Figure 5). These wounds expose the tree to pests and pathogens. Notably, the tree has had a good wound wood response to past branch failures as noted in the 2025 TRA report.

**Figure 5** The two wounds on the southwest stem. Photograph taken by Christine Johnson and brightened for clarity.

- **First order codominant stem, southwest stem (B, F)** – The southwest stem has two large trunk wounds because of the failures. This is a new defect on the southwest stem. One bowed branch remains and is exposed.

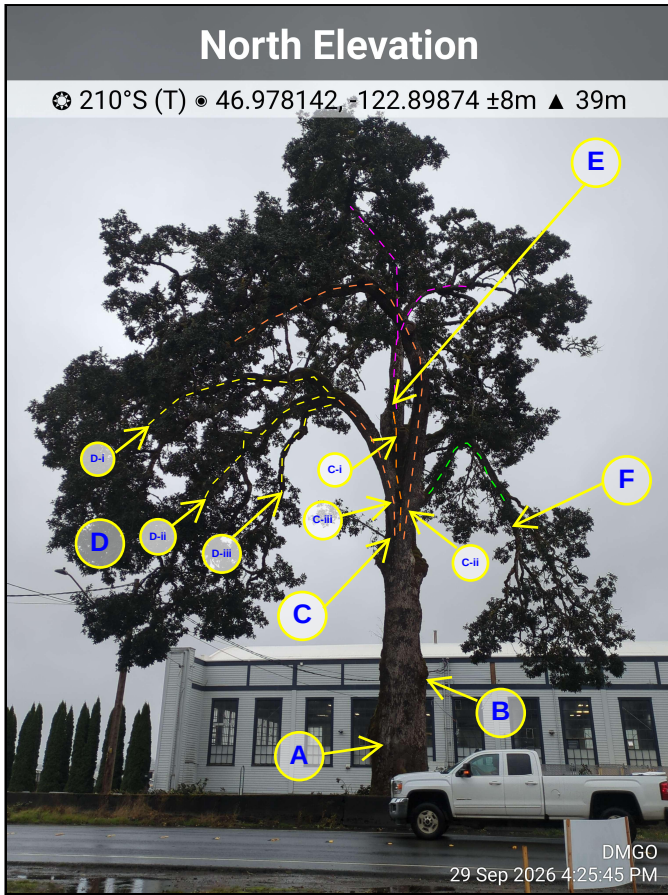
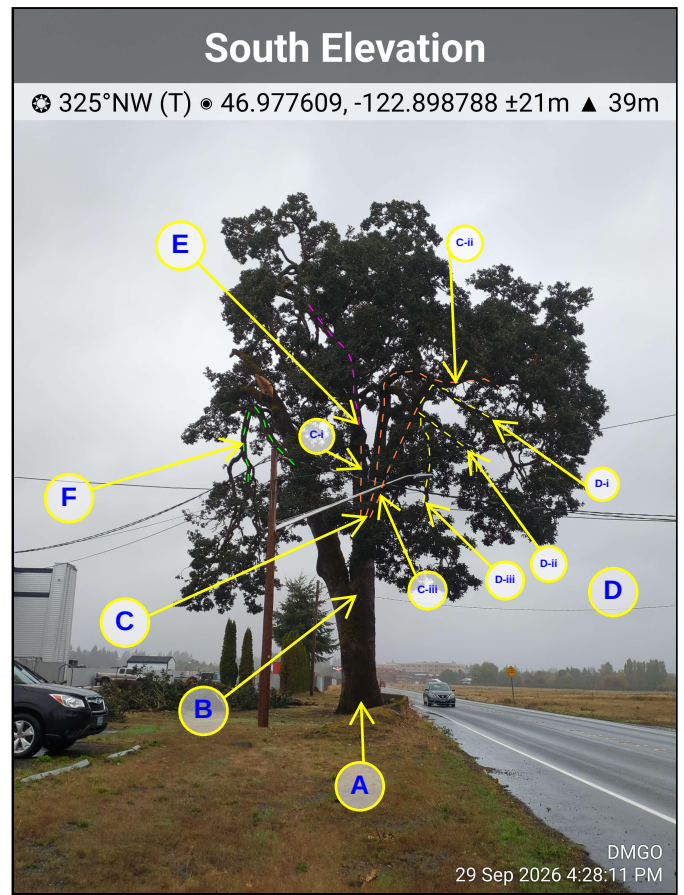
Attachment 5 – Photographs Depicting Defects of Concern

- **Trunk flare and trunk (A)** – I observed two openings in the trunk on the northwest and southeast sides. The opening on the northwest side was inhabited by bees and was at least 7 inches deep. The opening on the southeast side was about 3 inches deep. I did not observe any new defects on the trunk or first codominant split.

| Label | Defect of Concern |
|---|---|
| A | compromised wood in the stem; cavities/openings at ground level on NW and S sides |
